# **Glismann Road Development Plan:** *Contaminated Land Study*

Project No: 112064

**May 2020**

Cardinia Shire Council, PO Box 7, Henty Way, Pakenham, Victoria 3810

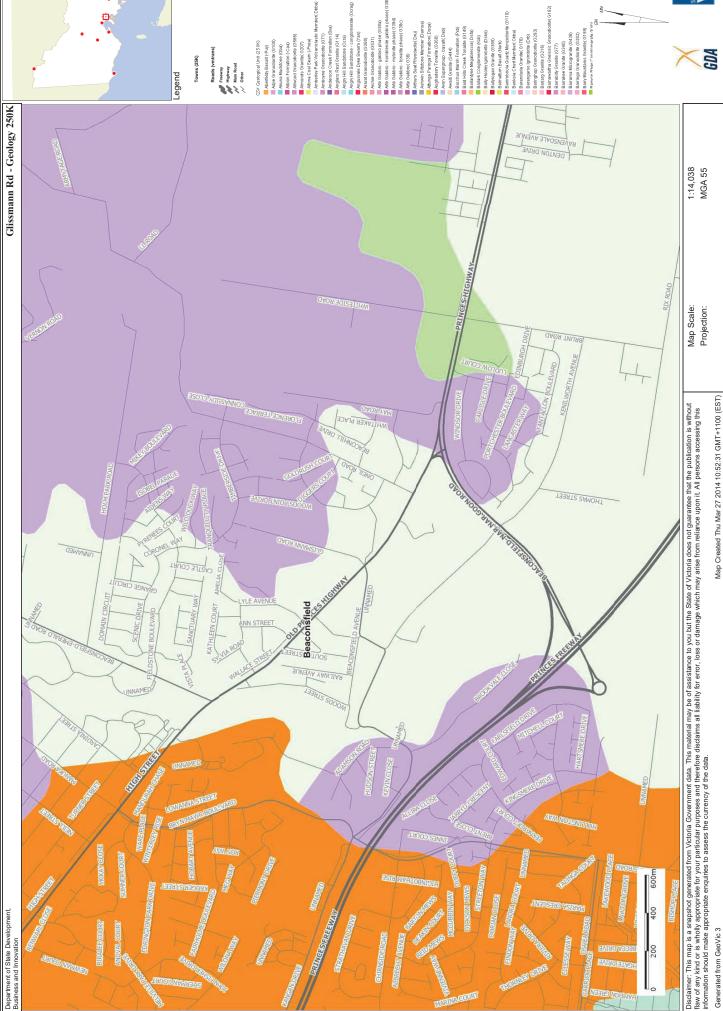
Figure 4 Geology Map

Glissmann Rd - Geology 250K
