GLISMANN ROAD, BEACONSFIELD STRUCTURE PLAN

CULTURAL HERITAGE MANAGEMENT PLAN No 11452

Completed November 22nd, 2010

GLISMANN ROAD, BEACONSFIELD STRUCTURE PLAN CULTURAL HERITAGE MANAGEMENT PLAN

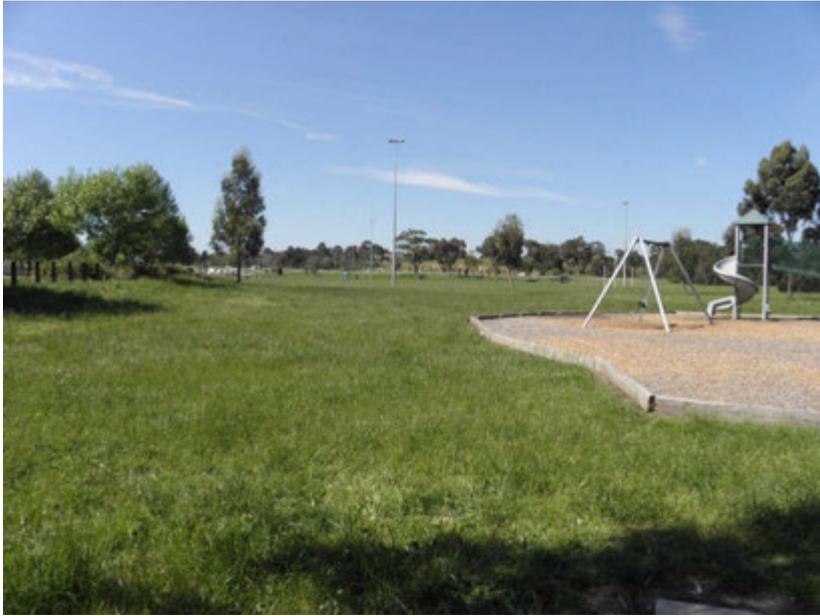
Photo 3

Heavily modified area (sporting oval & playground) and example of poor ground surface visibility; facing southeast.

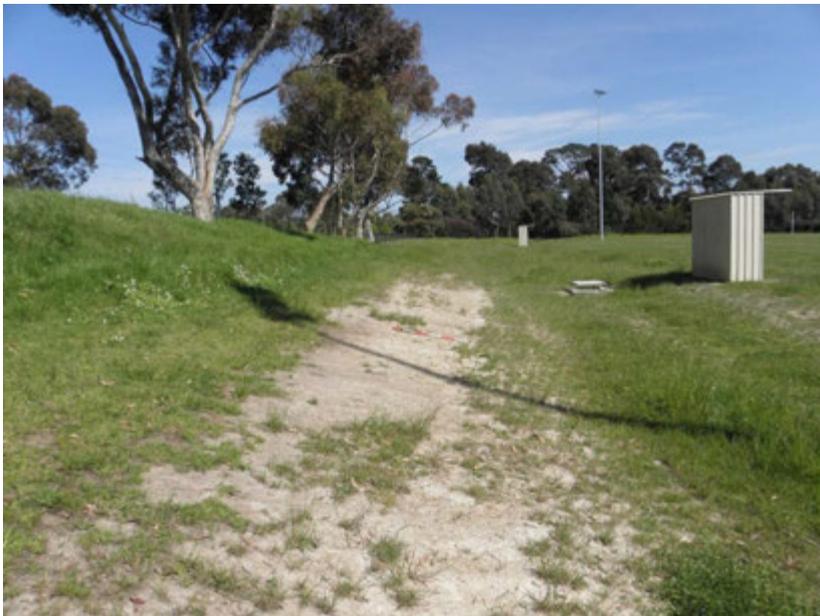
Photo 4

Area of improved ground surface visibility – albeit heavily modified; facing west.

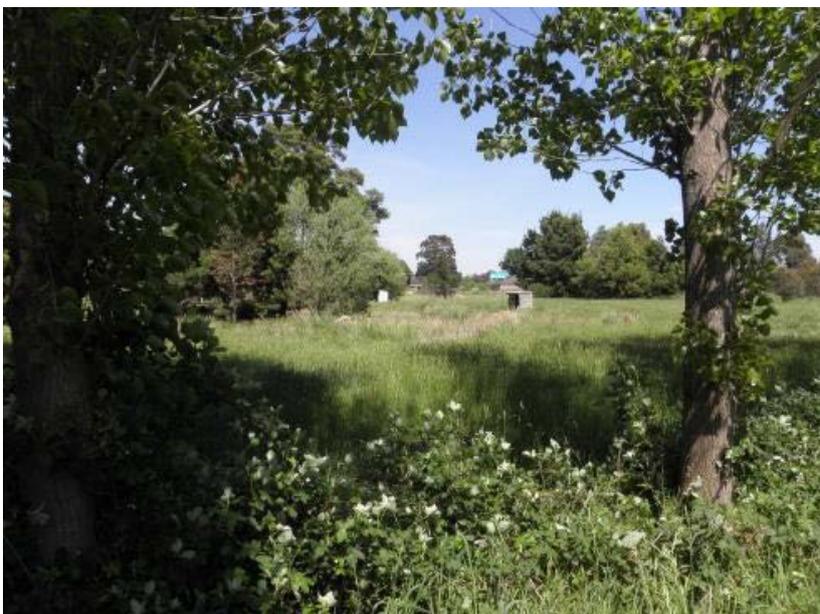
Photo 5

Swampy area west of Glismann Road within the activity area; facing south.

The balance of the activity area is not considered likely for Aboriginal cultural heritage due to the steep nature of the hill slopes (Photos 6, 8 & 9) and the swampy nature of the land at the base of the slopes (Photo 5), neither of which would have been conducive to Aboriginal occupation. Evidence of the difficulties in occupying the steep terrain was observed during the survey as extensive excavation and earthworks which have been conducted to allow for historic development (Photos 6 to 8).

Information pertaining to the swampy areas at the base of the slopes was also obtained during the course of the ground surface survey. Long-time resident (i.e. 20 years) of Glismann Road, Mrs Cheryl Campbell, informed Dale Owen (Tardis Enterprises Pty Ltd) that these low-lying areas were inundated on a yearly basis prior to residential development and associated drains being constructed in the area (Campbell, C 2010, personal communication, 29 October). During the standard assessment, despite recent relatively dry weather, these low-lying areas were observed to be swampy and not conducive to easy access (Photo 5).

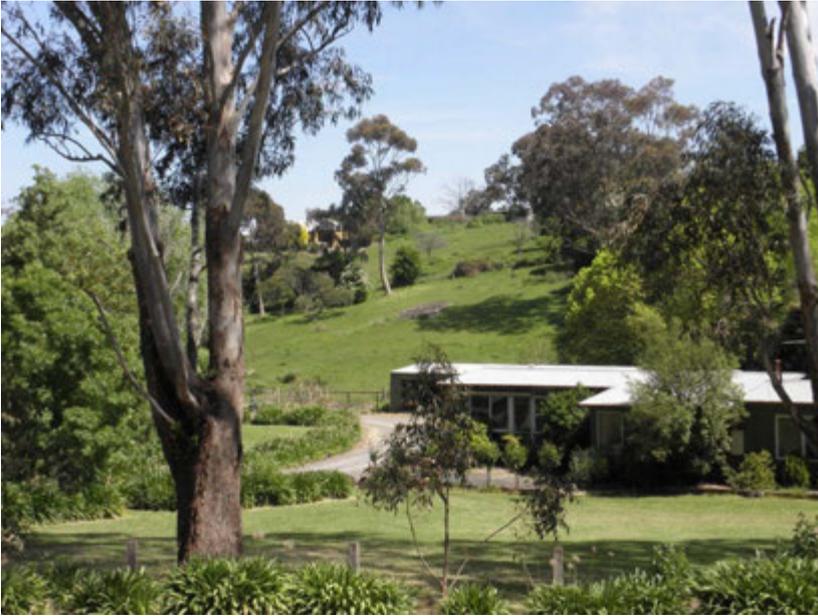
Photo 6

View showing heavily modified area for residences (foreground & top of hill in the background) and the steeply sloping hillside; facing west.

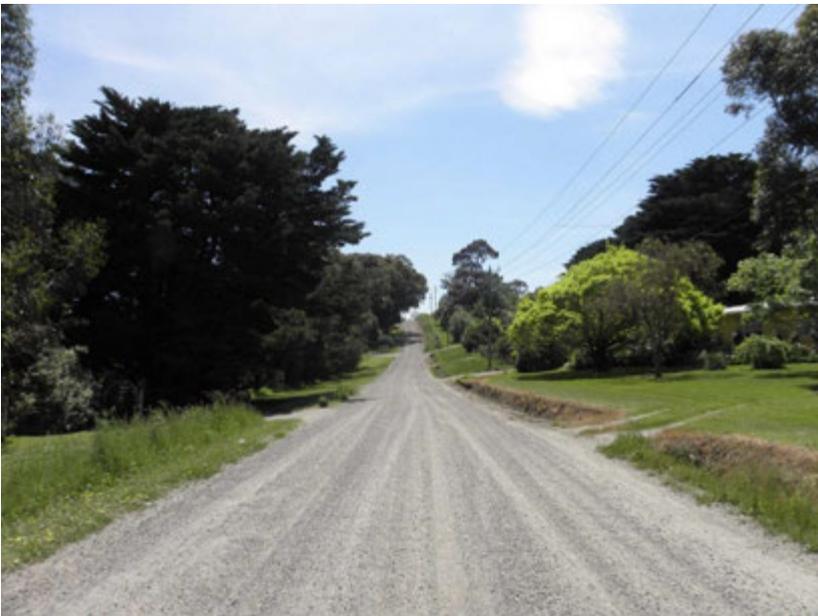
Photo 7

View along Glismann Road showing residences and their driveway entrances; facing north.

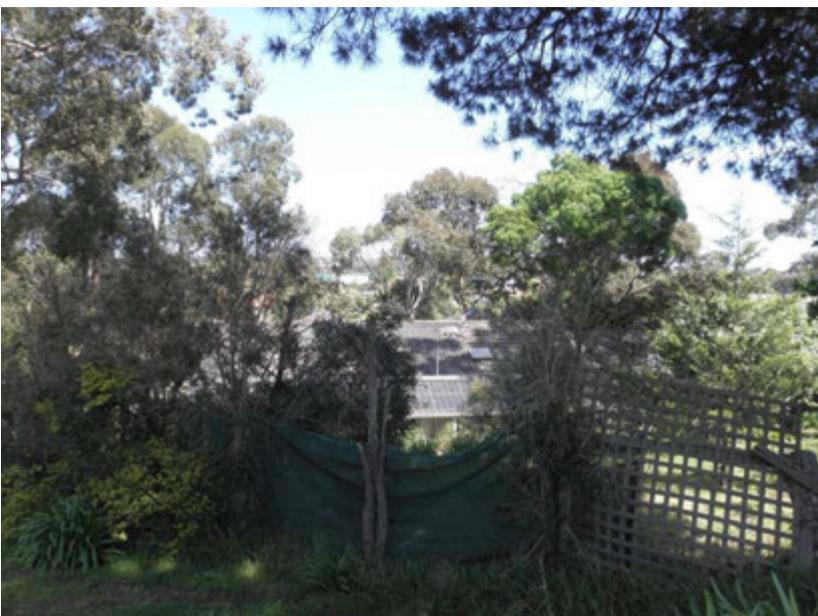
Photo 8

View over residence roof indicating steepness and modification of slope; facing southwest.

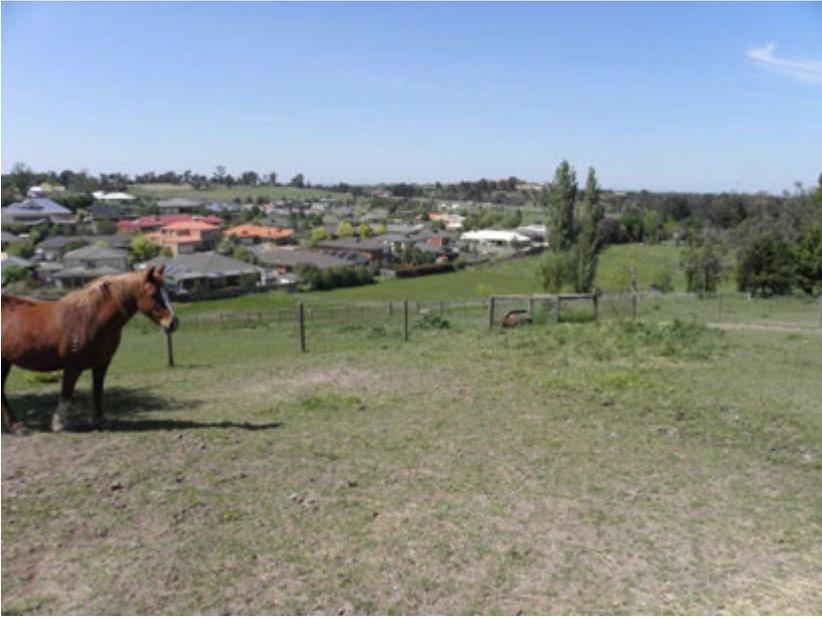
Photo 9

View from the top of the eastern ridgeline overlooking low-lying cleared ground and indicating the steep slope; facing southeast.
